Manhole Inspection Summary

Manhole # S23K__051MH

Insp Date: **6/10/08 3:13 PM**

Location Address: **S Norris St**

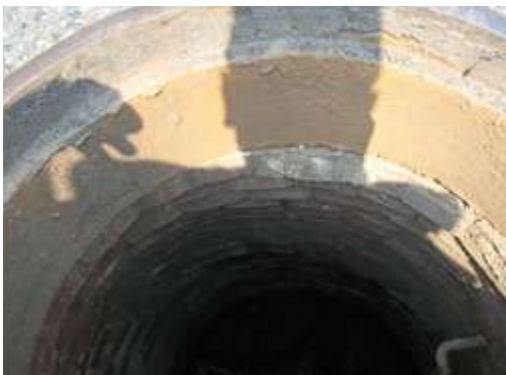
Defect 5

debris on bench

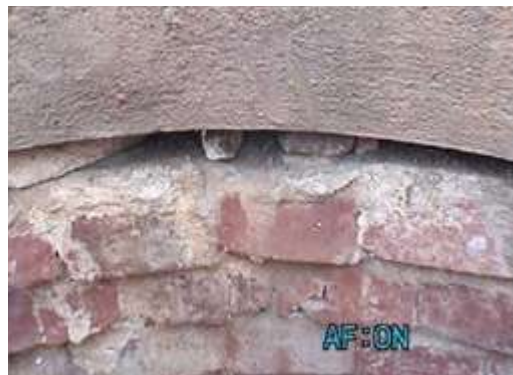
Defect 4

Condition: ☐ Sound ☐ Cracked ☒ **Leaks**

frame-lid infiltration

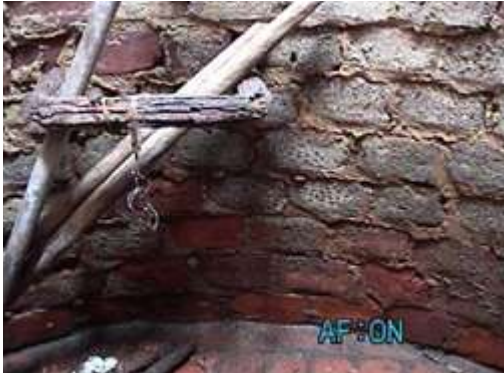
Defect 2

Condition: ☐ Sound ☐ Cracked ☐ Root Intrusion ☐ Loose Brick ☒ **Deteriorated**

Infiltration: ☐ None ☒ **Joint** ☐ Cracks ☒ **Mortar** ☐ Roots ☐ Wall

chimney deteriorated, signs of infiltration at joint/mortar

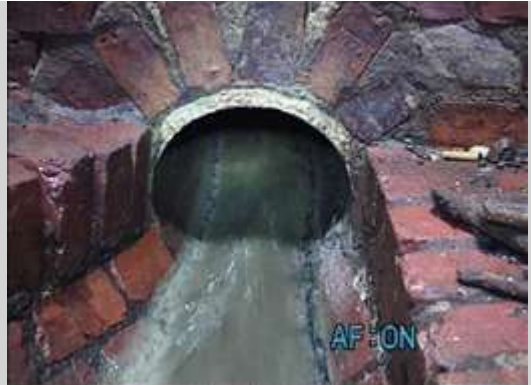
12 O'Clock Outflow

Pipe Height: **8.4** (in.) Rod and Bar (Angled)
Pipe Material: **Clay** ☐ Pipe Lined
Invert Depth: **9.10** (ft.) Flow Characteristics: **Fast**
Deposits: ☒ None ☐ Mud ☐ Sludge ☐ Debris ☐ Grease
Silt Depth: **0** (in.) Deposits Extent:
Infiltration: **None** Pipe Seal Cond: **Sound**

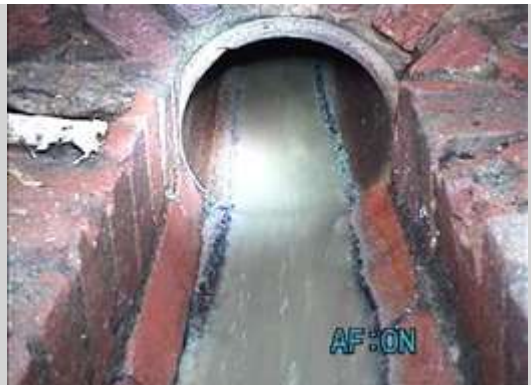
6 O'Clock Inflow

Pipe Height: **8.4** (in.) Rod and Bar (Angled)
Pipe Material: **Clay** ☐ Pipe Lined
Invert Depth: **8.96** (ft.) Flow Characteristics: **Fast**
Deposits: ☒ None ☐ Mud ☐ Sludge ☐ Debris ☐ Grease
Silt Depth: **0** (in.) Deposits Extent:
Infiltration: **None** Pipe Seal Cond: **Sound**

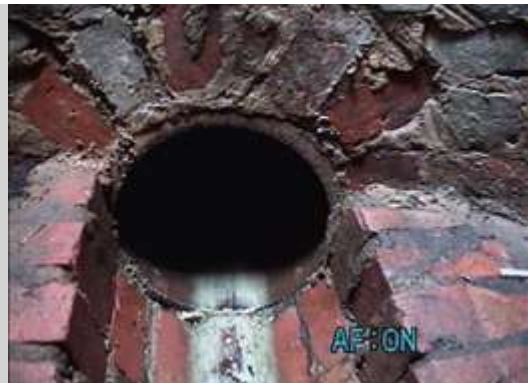
9 O'Clock Inflow

Pipe Height: **8.4** (in.) Rod and Bar (Angled)

Infiltration: **None** Pipe Seal Cond: **Sound**
